# Analytical report on corroded nails from *Peggy*

**Report commissioned by Manx National Heritage**

# PEGGY: ANALYSIS OF NAILS AND WOOD

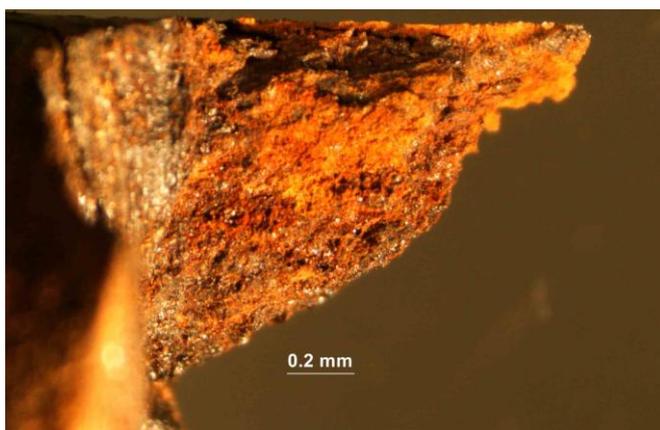
Visual inspection used a stereo microscope at magnifications of x4 to x 20 with digital imaging camera and software attached. The appearance of all iron nails followed a standard pattern (figures 1 and 3-8). Corrosion is seen soft orange-red-brown powdery, with a denser underlying corrosion layer that is darker. The upper layer is likely the interface between mineralised iron and residual iron core. Darker brown patches of soft corrosion and the hard surface of corrosion pustules will contain some  $\beta\text{FeOOH}$ . This is unstable and supports corrosion of iron at low humidity (Watkinson and Lewis 2005). Other lighter orange areas are likely to comprise mostly  $\alpha\text{FeOOH}$ , which poses no threat to the object.

Figure 1 – Sample 0014/: soft powdery corrosion on nail surface.

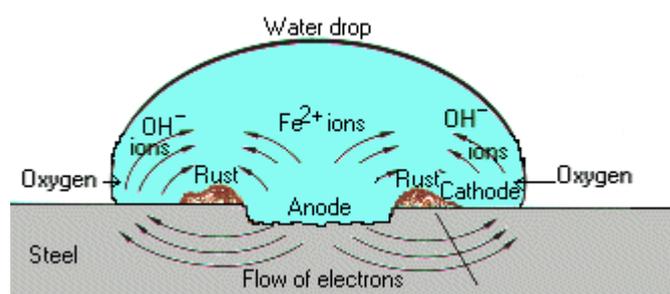
Pustules are created by activation of electrolyte spots that are formed in high humidity. The electrolyte is supplied by soluble compounds on the metal surface. Corrosion consumes the iron with the growth of both  $\alpha\text{FeOOH}$  and, in chloride rich environments,  $\beta\text{FeOOH}$  as an outer skin. In this instance the electrolytes will comprise chloride compounds formed from the chloride provided by the marine environment where Peggy spent her life. Chloride will have been drawn into the iron as a counter ion in the corrosion process. When the water evaporates in drier atmospheres corrosion ceases and the outer skin forms a solid shell creating a hollow sphere. High humidity will reactivate the process and eventually large corrosion blisters form.

Figure 2. Pustule formation on iron objects

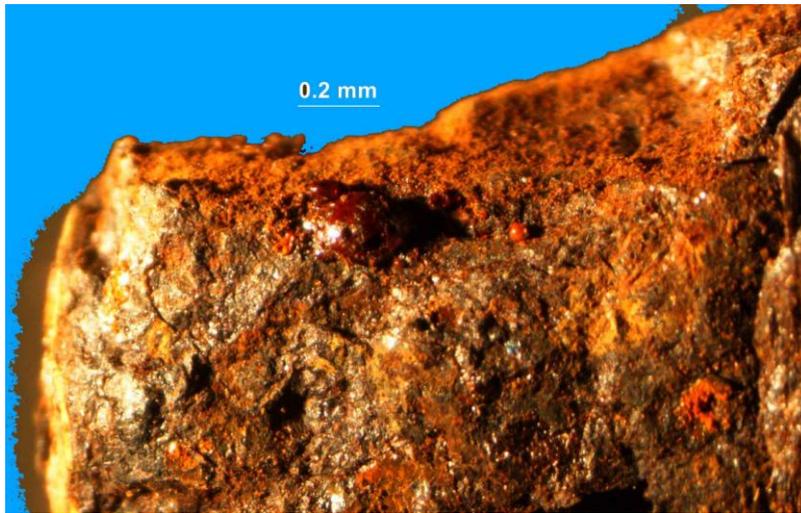
*Figure 3. Nail 0014/1: centre left is a well developed corrosion pustule (dark orange-red); to its right is a much smaller newly developing pustule (orange).*

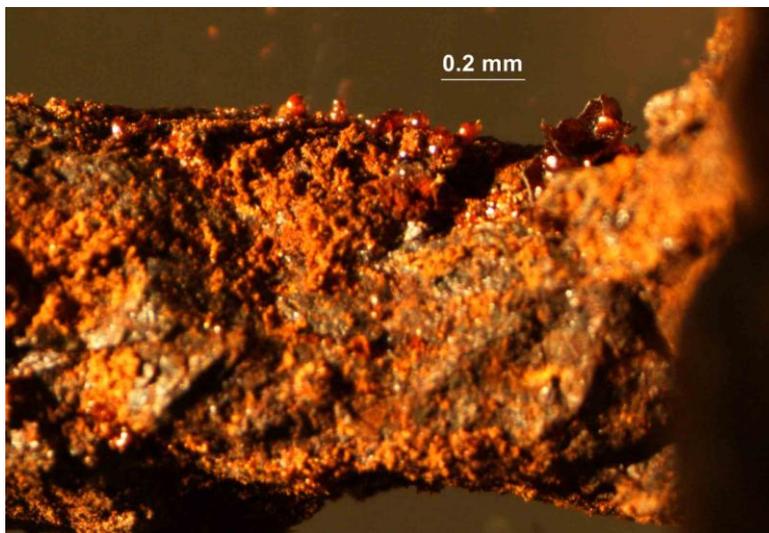
*Figure 4. Nail 0014/2: large broken corrosion pustule is visible on the surface (top right). Elsewhere there are large numbers of corrosion pustules of all sizes and colours. The light orange pustules are in an early stage of growth. None of these are currently active due to the low relative humidity.*

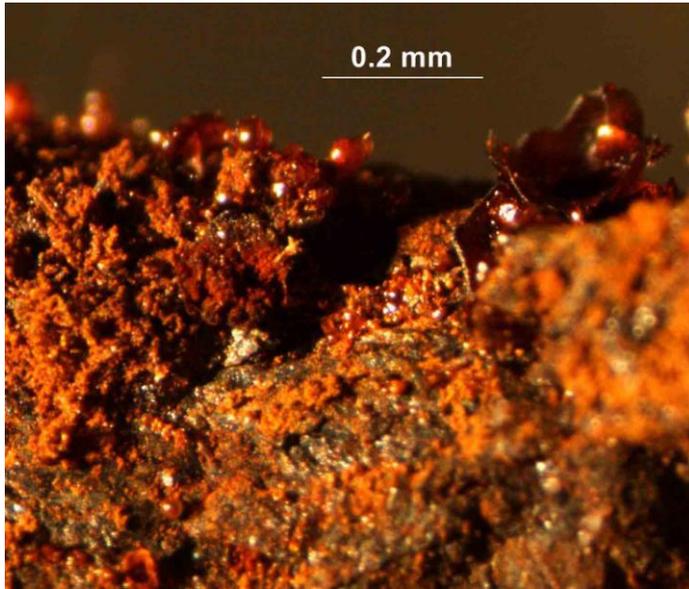
*Figure 5. Nail 0014/2: close up of large broken corrosion pustule in figure 4. It is visible on the surface top right.*

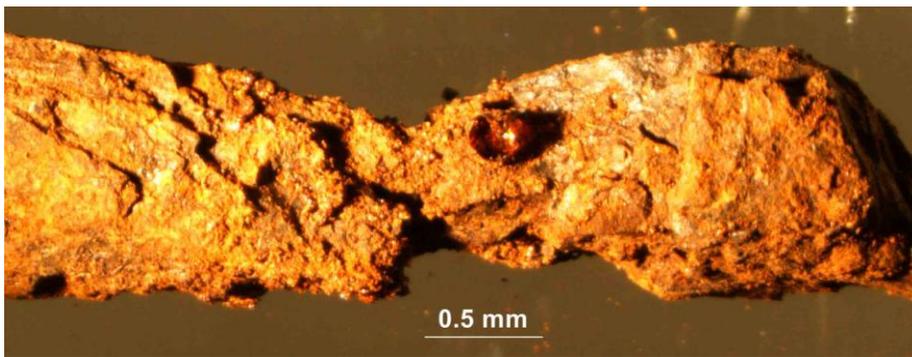
*Figure 6. Nail 0014/3: broken corrosion pustule. There is extensive thinning of nail in centre compromising structural integrity.*

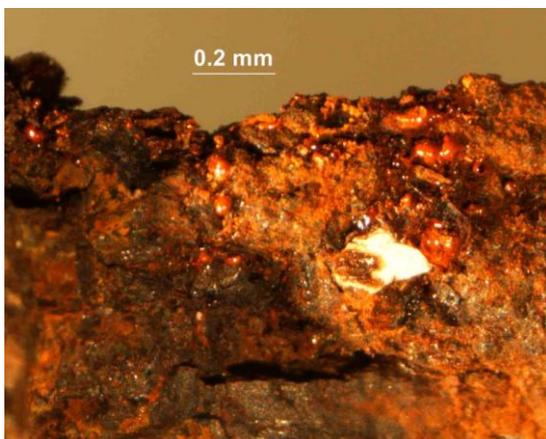
*Figure 7. Nail 0014/4: corrosion pustules.*

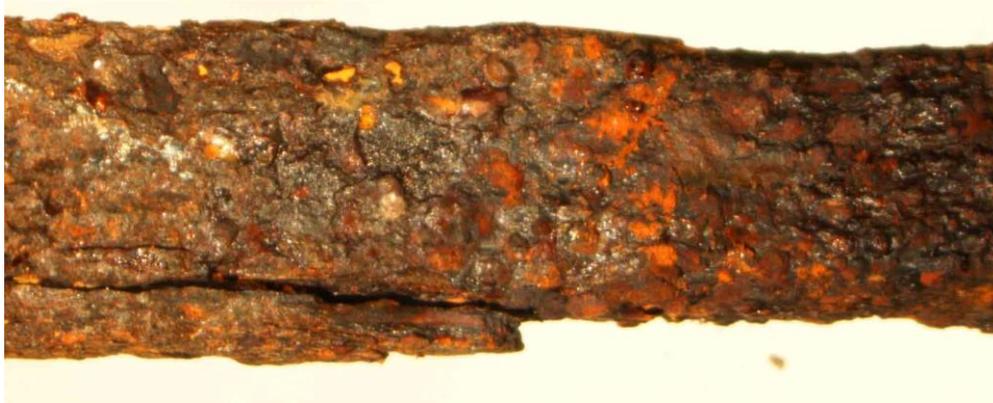
Both broken and unbroken shells can be seen on all the iron from the Peggy (figures 3-7). These have been activated in a high relative humidity prior to the nails being sent to Cardiff. Further evidence of active corrosion is the lamination of the corrosion layers from the remaining metal core seen in figure 8. Overall the physical integrity of the nails is compromised by extensive loss of metal with localised thinning evident in

figure 8. This is likely to have occurred at an area where oxygen levels around the nail change from high to low.

*Figure 8. Nail 0014/6: corrosion pustules and lamination of corrosion product at metal/corrosion layer interface.*

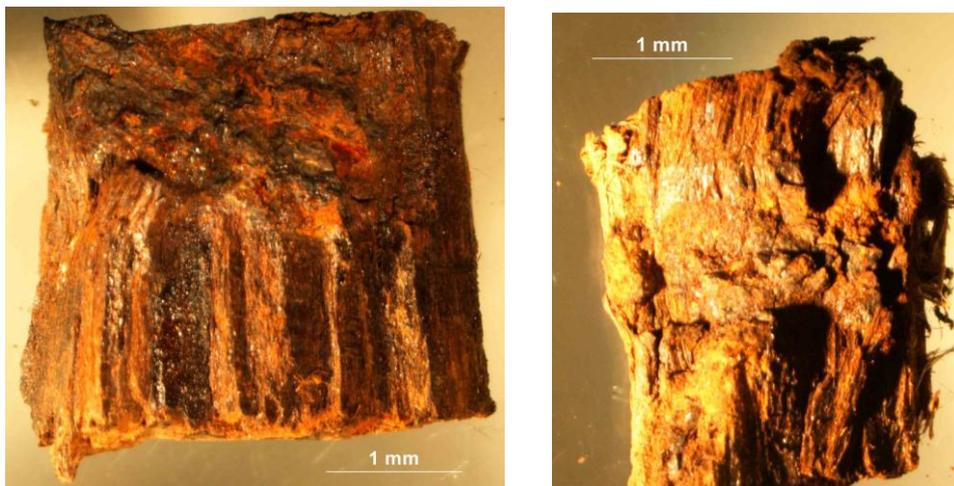
*Figure 9. Wood sample on the lhs is showing signs of mineralisation. While the wood sample on the rhs is showing similar signs of mineralisation, it is less advanced, as it still contains fibrous wood fibres.*

The wood in the vicinity of the nails is infused with iron corrosion products and is beginning to mineralise (figure 9). The iron corrosion products are

hydrolysing the cellulose in the wood due to the acidity from hydrolysis of  $\text{Fe}^{2+}$  ions [1].
